**183<sup>rd</sup> Street at Pulaski Road**  
**Hazel Crest, IL**

- RLR Photo Enforcement System monitors violations occurring on the northbound approach of the intersection
- RLR Photo Enforcement System installed: February 16, 2009

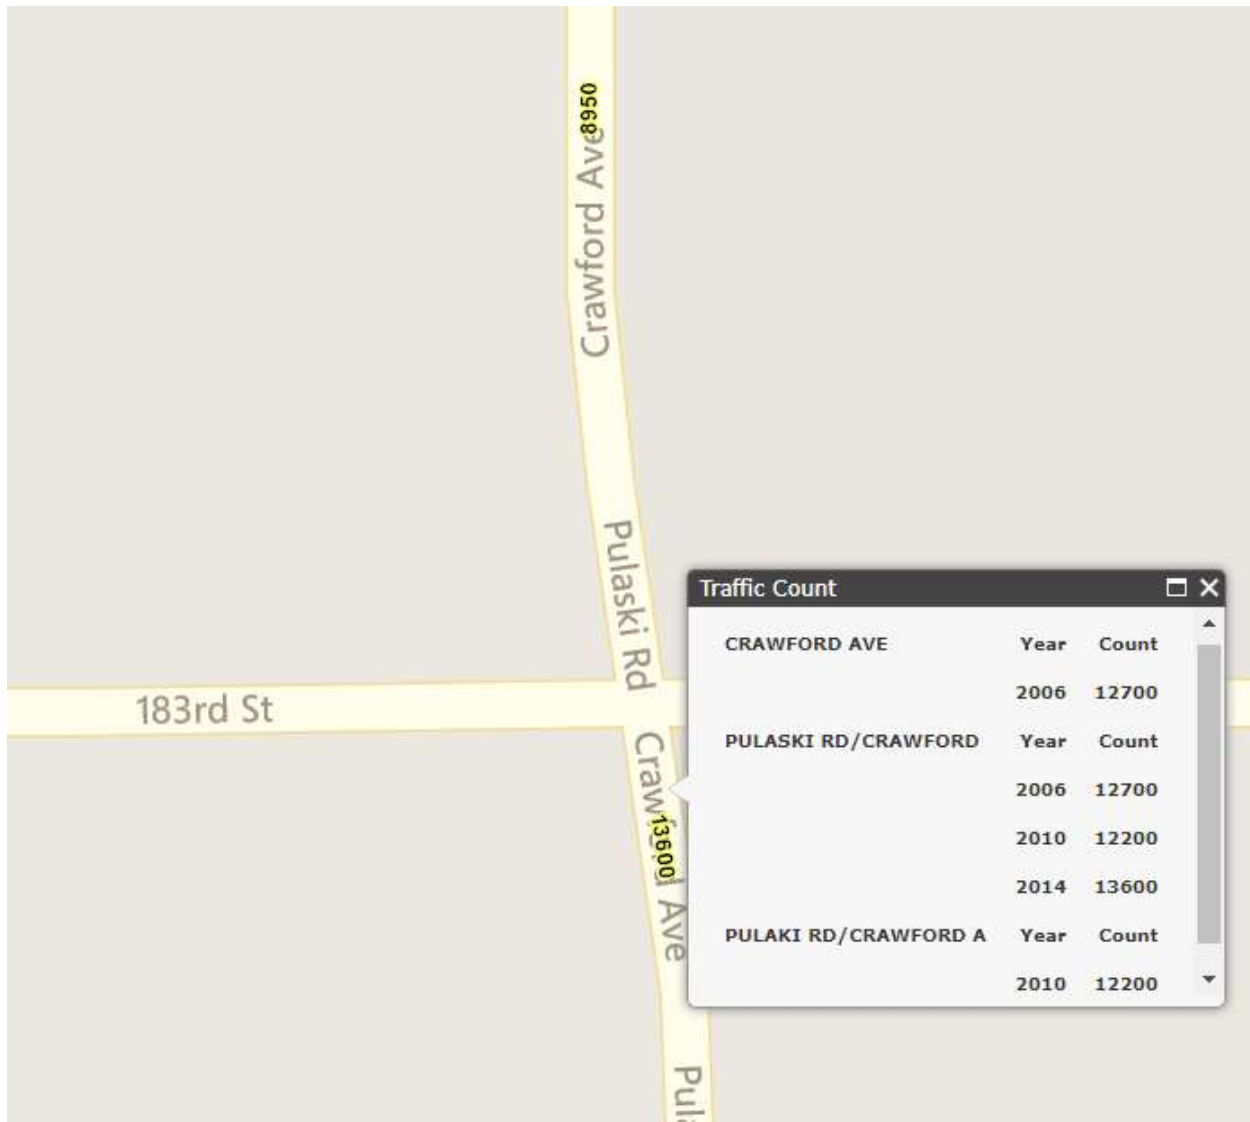
183<sup>rd</sup> Street at Pulaski Road (Northbound)

- 12,700 (2006)
- 12,200 (2010)
- 13,600 (2014)

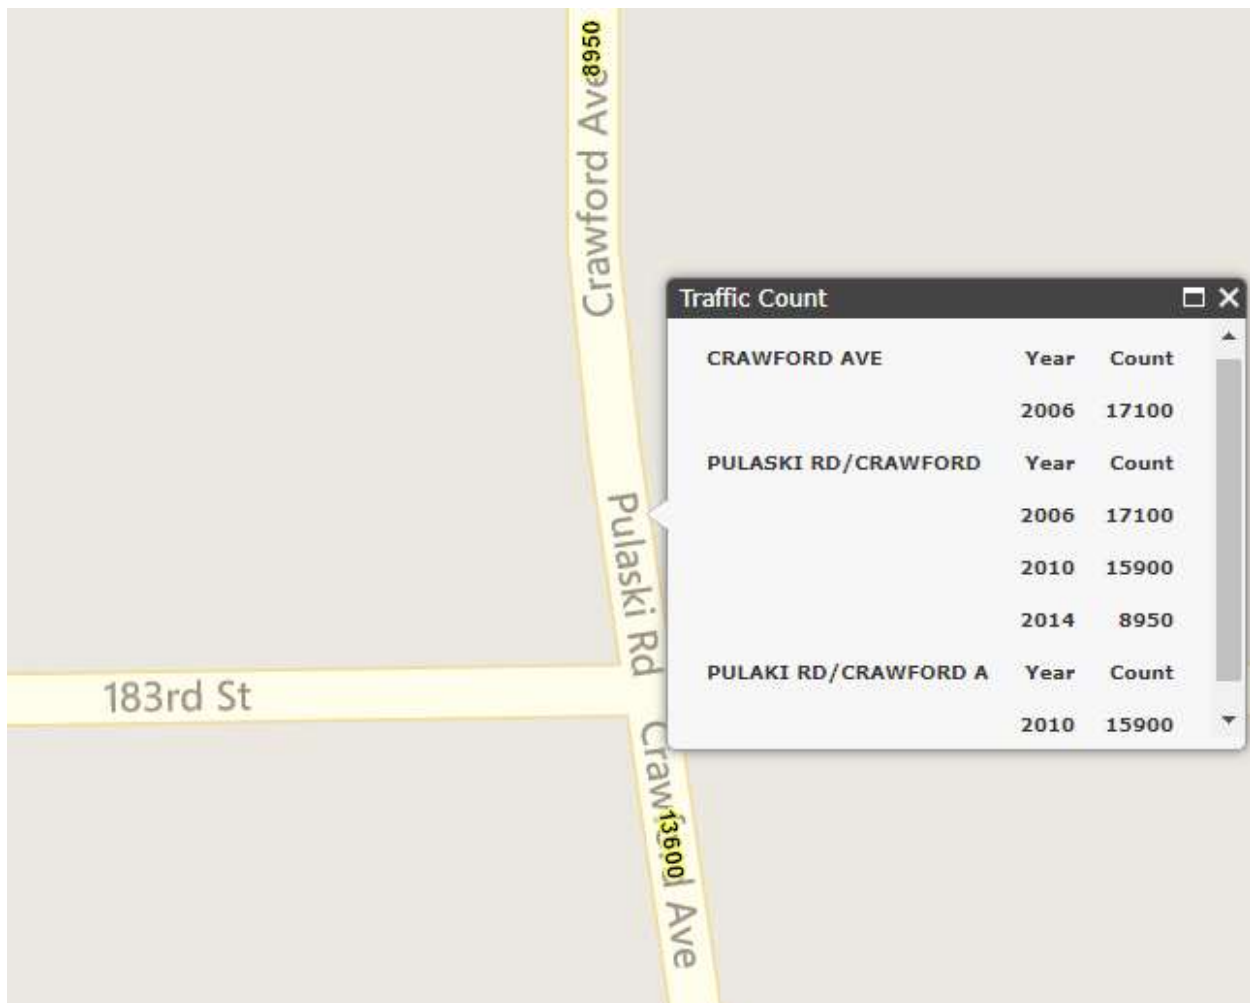
183<sup>rd</sup> Street at Pulaski Road (Southbound)

- 17,100 (2006)
- 15,900 (2010)
- 8,950 (2014)

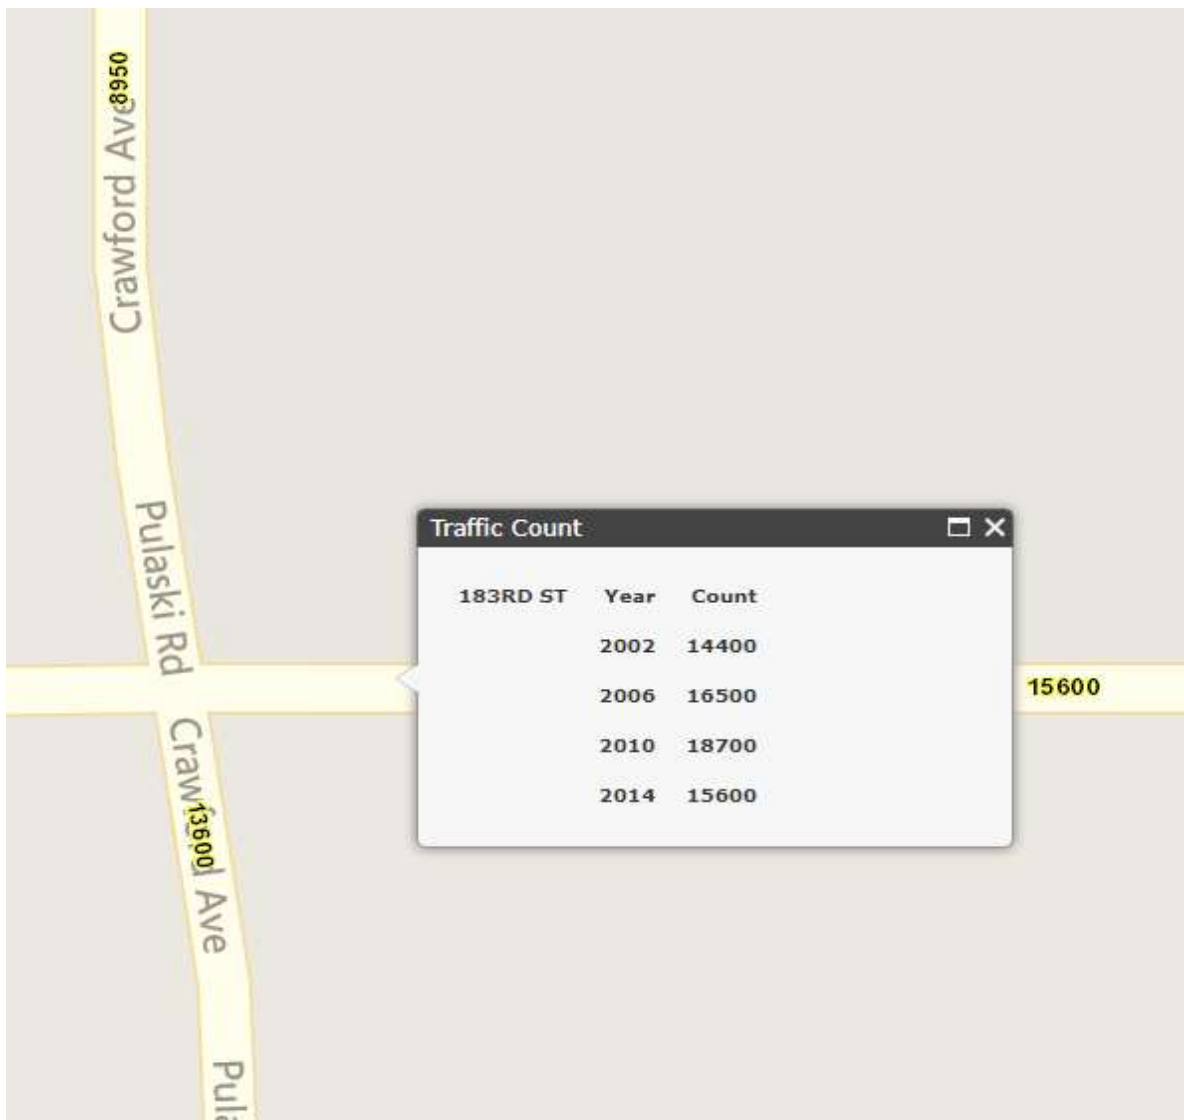
183<sup>rd</sup> Street at Pulaski Road (Eastbound/Westbound)

- 14,400 (2002)
- 16,500 (2006)
- 18,700 (2010)
- 15,600 (2014)
